Amendment 39-17630; AD 2013-21-06]

Airworthiness Directives; Eurocopter Deutschland GmbH Helicopters

ACTION: Final rule.

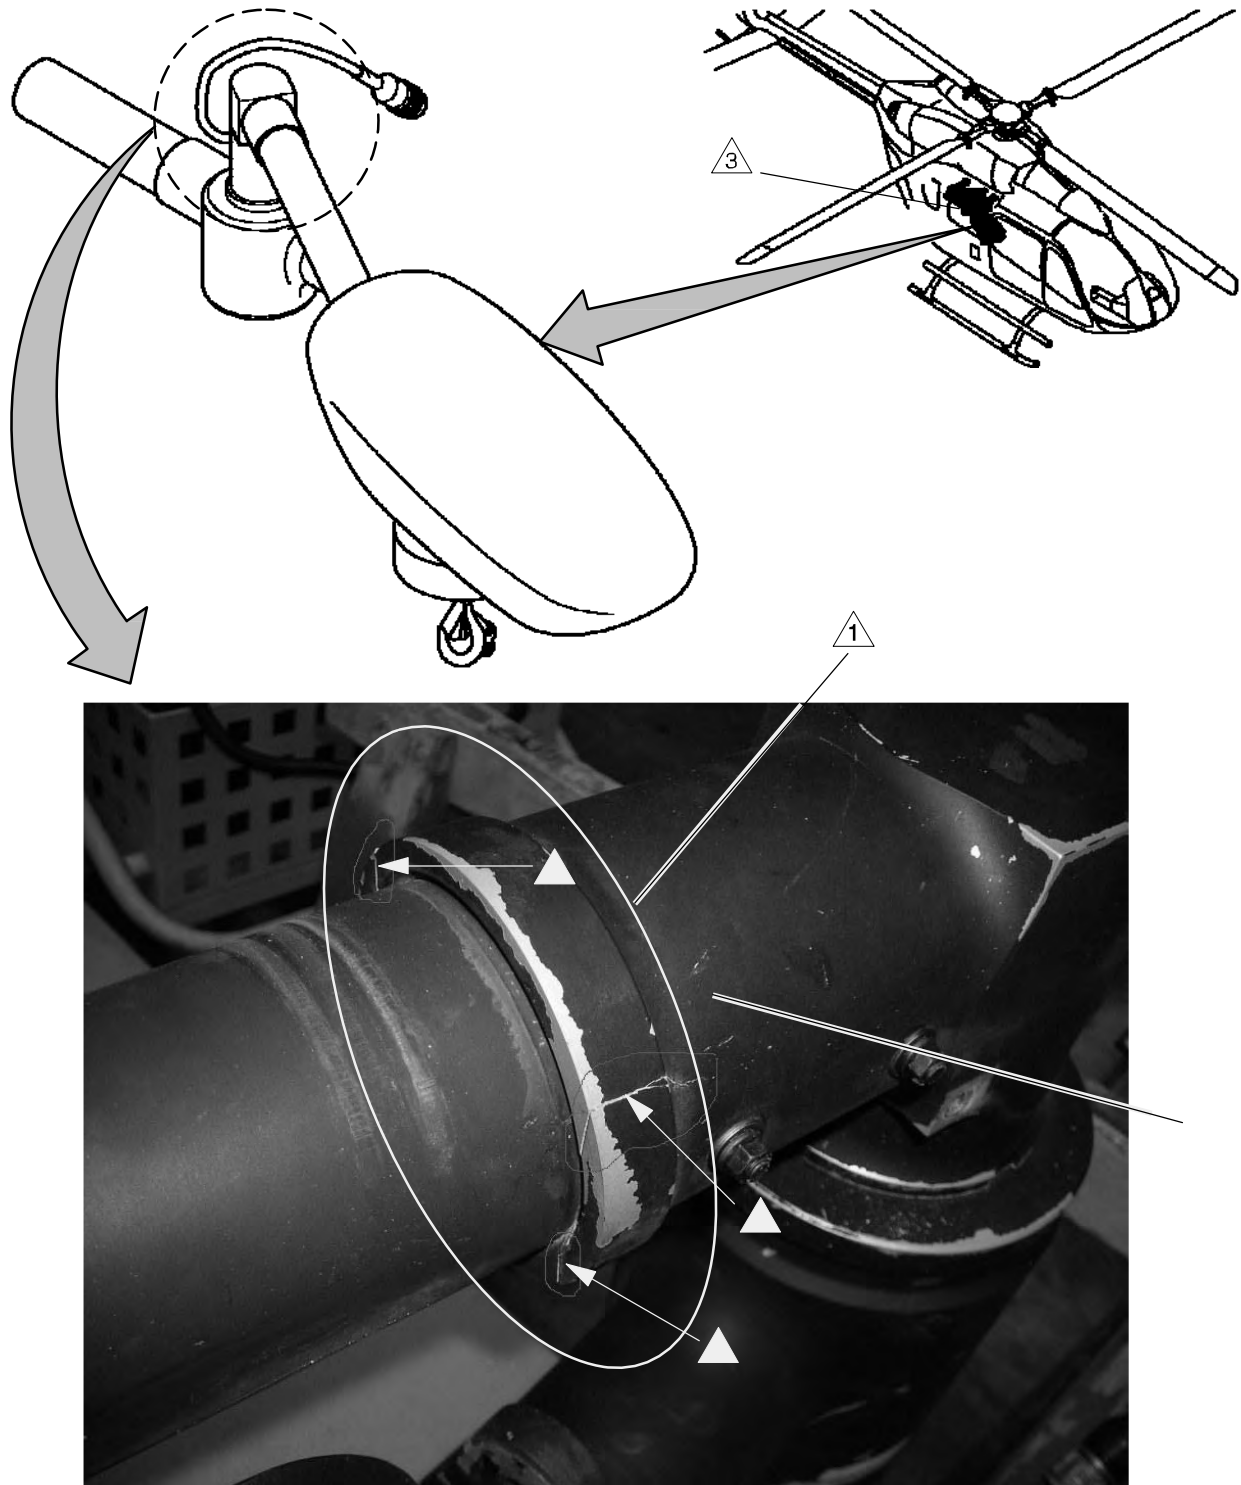
Figure 1 to Paragraph (e)

This AD defines the unsafe condition as a crack in the boom. This condition could result in loss of the boom and attached loads, and subsequent loss of helicopter control.

(1) Before further flight, and thereafter before the first flight of each day until you have performed the inspection required by paragraph (e)(2) of this AD, clean the hoist and visually check for a crack, paying particular attention to the areas that are circled as depicted in Figure 1 to paragraph (e) of this AD. The actions required by this paragraph may be performed by the owner/operator (pilot) holding at least a private pilot certificate, and must be entered into the aircraft records showing compliance with this AD in accordance with 14 CFR §§ 43.9 (a)(1)-(4) and 14 CFR § 91.417 (a)(2)(v). The record must be maintained as required by 14 CFR §§ 91.417, 121.380, or 135.439.

(2) Within 30 days, perform a dye penetrant inspection of the boom in accordance with the Accomplishment Instructions, Section 2.D, of the Goodrich Service Bulletin 44307-500-03, Revision 2, dated April 30, 2010 (SB).

(3) If a crack exists in the boom, replace the cracked boom with an airworthy boom before further flight.
